# Ōtūmoetai Pool, Tauranga

FACILITY REVIEW, CONDITION ASSESSMENT & ACCESSIBILITY REPORT

ARCHITECTURE HDT, BECA

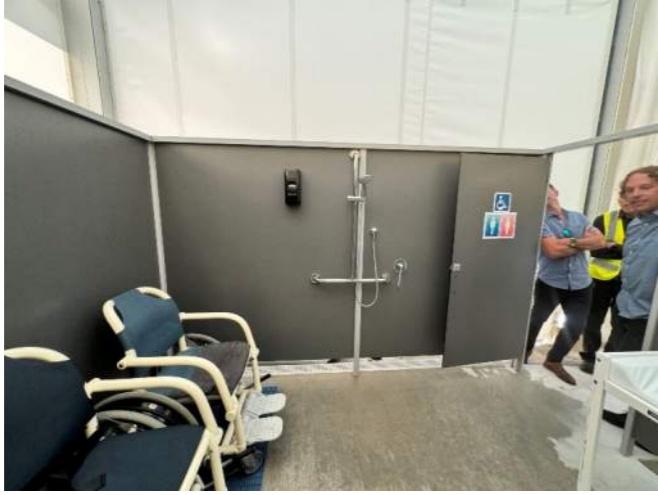
Y
	Horizontal rail 900 - 1000mm above floor.	Y
	Vertical rail away from corner.	Y
	Capable of supporting full weight of an adult at any point. Fixed into partition panel wall with aluminium vertical stiffeners. Fixing to be inspected, to ensure adequate fixing support is provided.	TBC

30 – 40mm diameter.	Y
	50 – 60mm clearance from wall. Check aluminium vertical post encroaches into grip space of shower grab rail.	TBC
	Lever control mixer.	Y

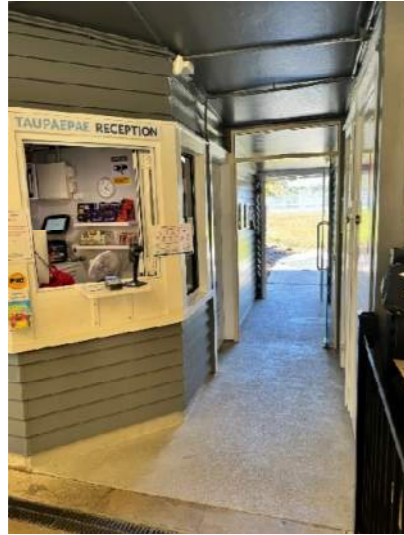
Counters and Desks:	Reception counters and desks are on accessible route.

N
	Reception counters and desks have at least one accessible space for both staff and visitors. <b>Scope Recommendation:</b> Provide lowered counter for accessible use	N
	Minimum 900mm wide.	N
	540 – 600mm deep.	N
	Minimum 675mm under.	n/a
	Maximum 755mm to top.	N

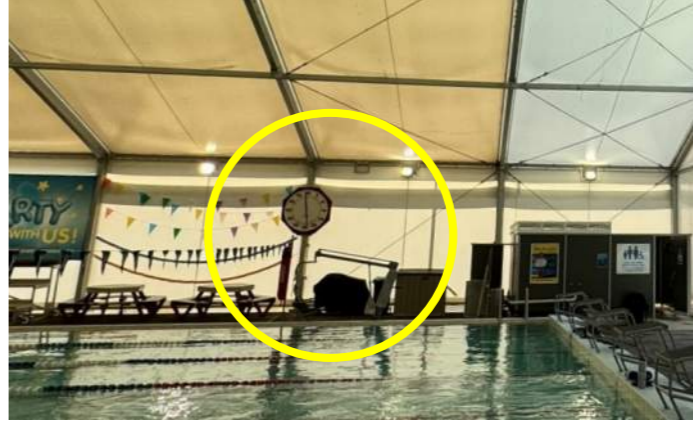
Where listening system is installed or available, signage indicating availability is provided at the main doors or doors to the enclosed space.	n/a
Swimming Pools:	Accessible toilets, showers and changing rooms, on an accessible route, provided.	Y
	Swimming pool is available from an accessible route.	Y
	Unaided access to the water is available from the poolside. Hoist is provided but will require operation of a pool attendant. <b>Scope Recommendation</b> Provide drop in ramp or self-operable pool hoist.
